**LAKE COLUMBIA
STS OUTFALLS**
JACKSON COUNTY, MICHIGAN

Figure 10: Storm Drain Outfalls

Storm Drain Outfall Survey

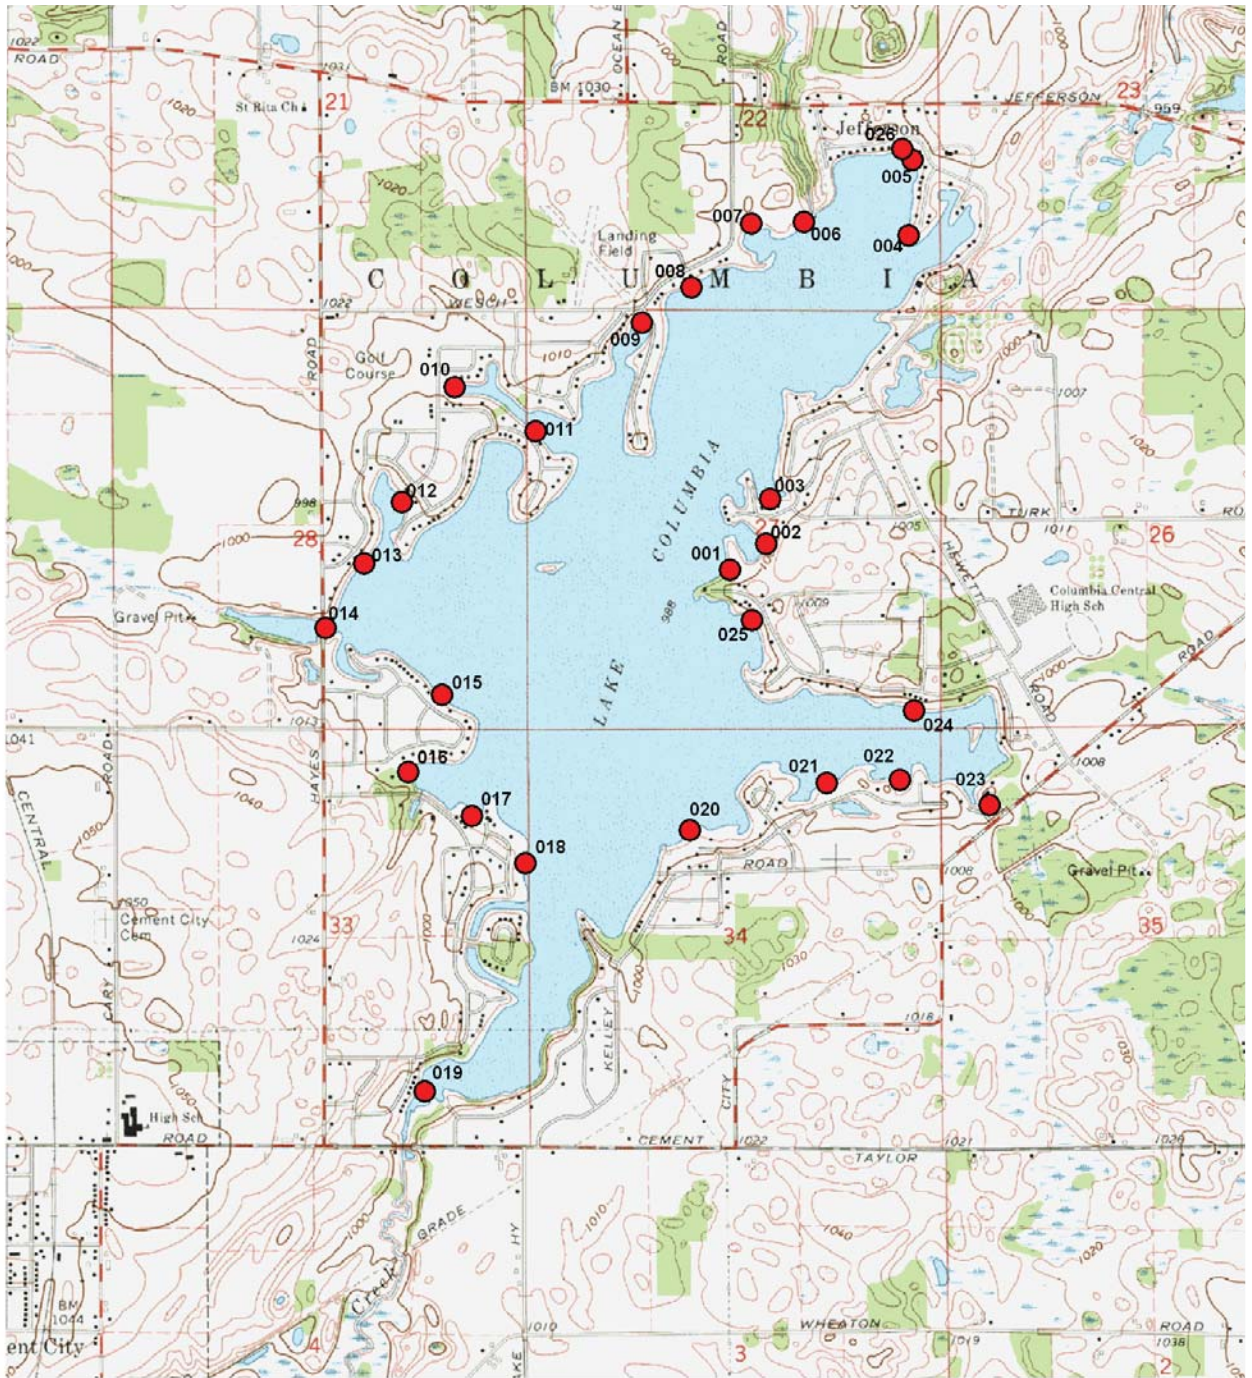
A survey of storm drain outfalls around Lake Columbia was conducted by staff from Progressive AE on August 1, 2007. The initial field survey identified 26 storm drain (SD) outfalls (Figure 9 and Appendix D).
